Office Of Inspector General "Is LA Metro Ready for Climate Change?"

Rail Vulnerabilities and Adaptations

Executive Management Committee

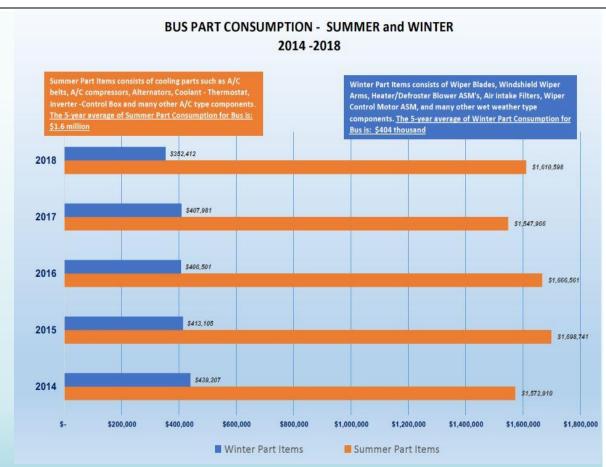
- Buses break down more summer, 10% decrease in available buses
- Bus equipment has a higher failure in summer resulting in unscheduled repairs
- Current Bus Part Consumption \$1.6 Million in summer vs. \$404 thousand for winter
- Maintenance costs could significantly increase over extended summer, greater temperatures

- 1. Plan for increased maintenance
- Pre-Summer Operations Summits
- 3. Parts and spares inventory readiness
